**AFRL-RQ-WP-TR-2014-0231**

**RAPID RESPONSE RESEARCH AND DEVELOPMENT  
(R&D) FOR THE AEROSPACE SYSTEMS DIRECTORATE  
Delivery Order 0021: Engineering Research and Technical Analyses of  
Advanced Airbreathing Propulsion Fuels**

**Subtask: Engine and Pump Studies Utilizing JP-8 and Alcohol-to-Jet (ATJ)  
Blends**

**AUGUST 2014  
Interim Report**

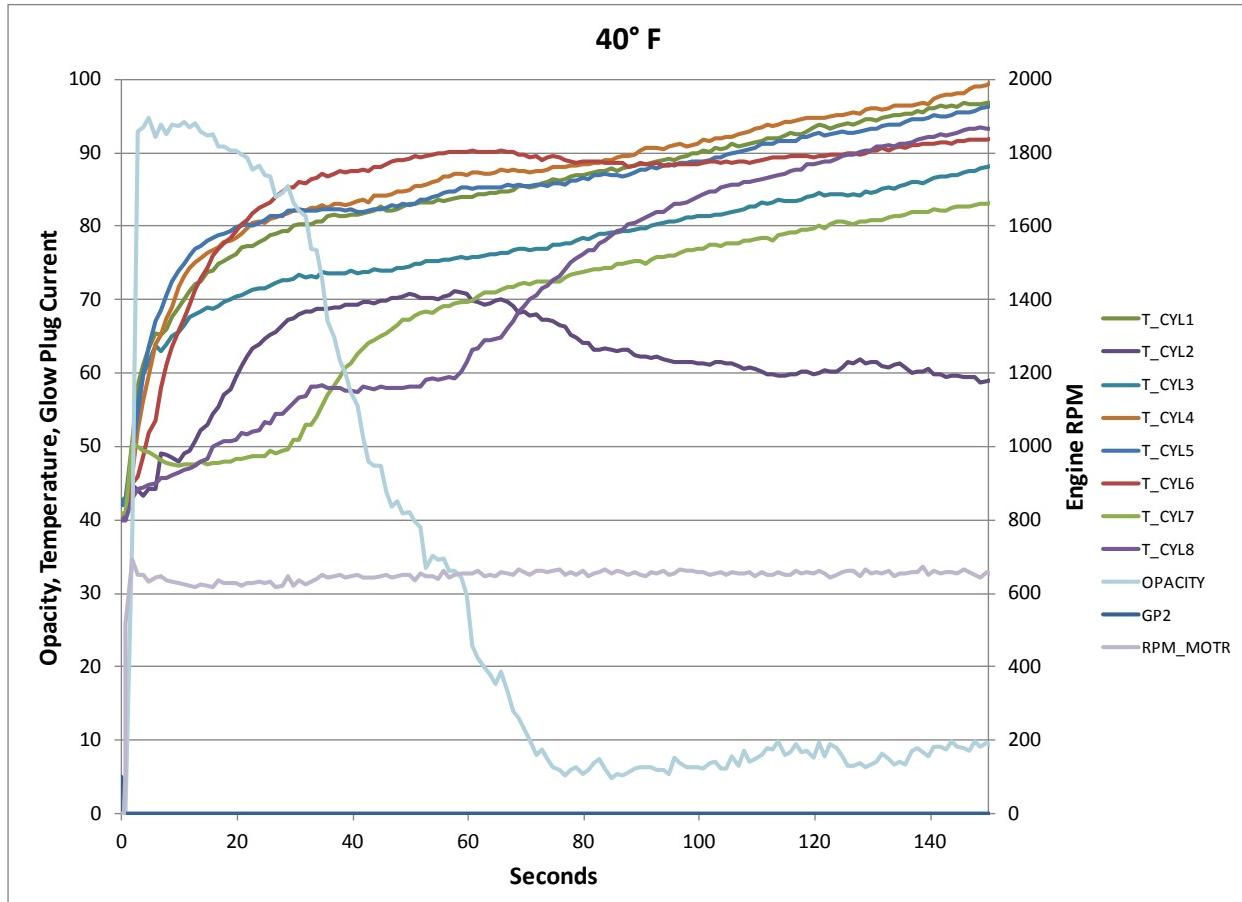
Figure C-16. Low Cetane Cold Start at 40 °F

At 40 degrees Fahrenheit, the engine was not able to start without the aid of glow plugs. The glow plugs were enabled for 10 seconds prior to ignition, and disabled after. The engine was able to start, but 3 of the cylinders immediately quit firing. As seen in Figure C-16, cylinder 2 was the first to relight, followed 30 seconds later by cylinder 7, and after another 30 seconds cylinder 8 reignited. Although the temperature of cylinder 2 does not increase with time as the other cylinders, combustion was occurring as indicated by the low opacity values.

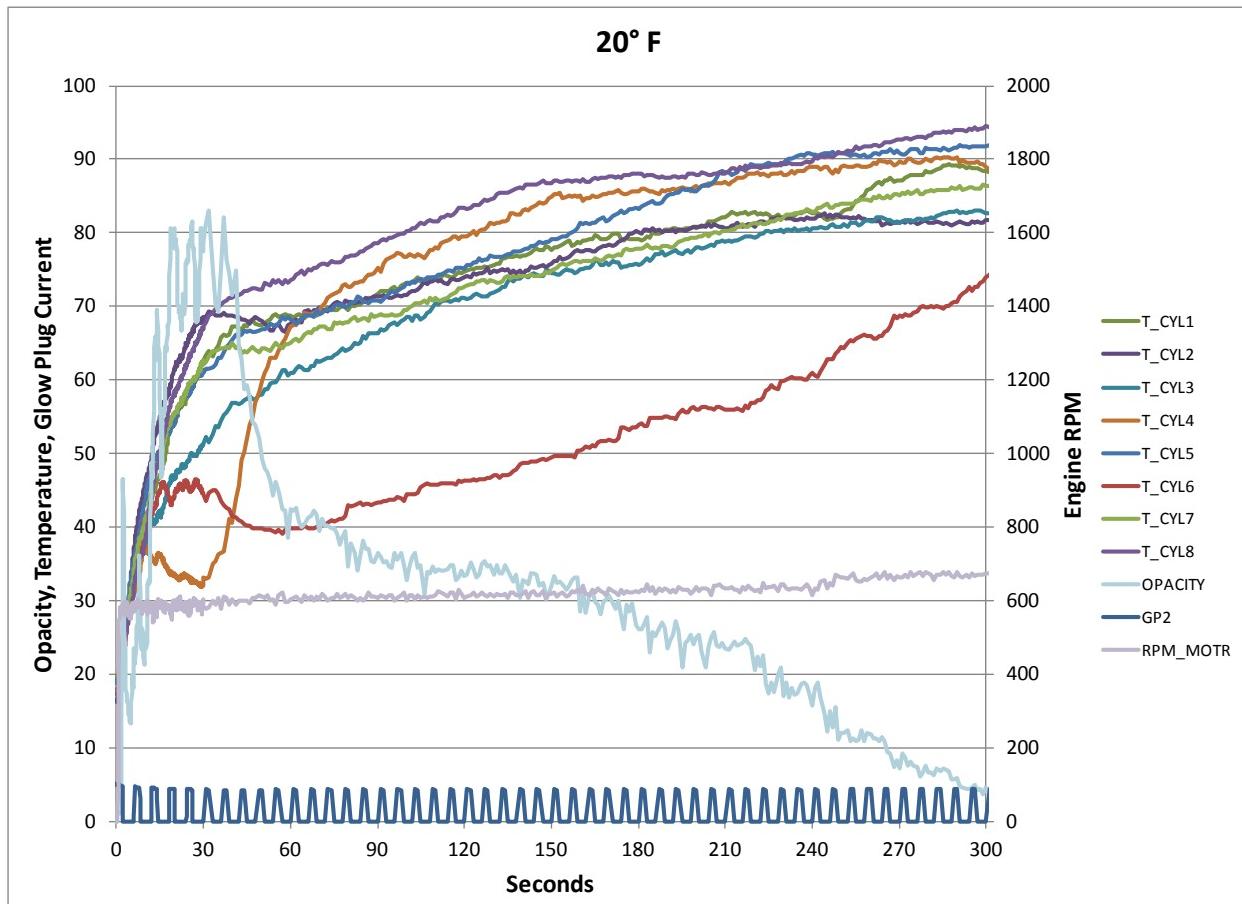
**Figure C-17. Low Cetane Cold Start at 20 °F**

At 20 degrees Fahrenheit, the engine was unable to start without the use of glow plugs. As seen in Figure C-17, the engine started immediately with no hesitation, firing on all cylinders. However, cylinder 4 stopped firing a few seconds after ignition, then resumed about the time cylinder 6 stopped firing. Cylinder 6 fired intermittently until full relight around 300 seconds.

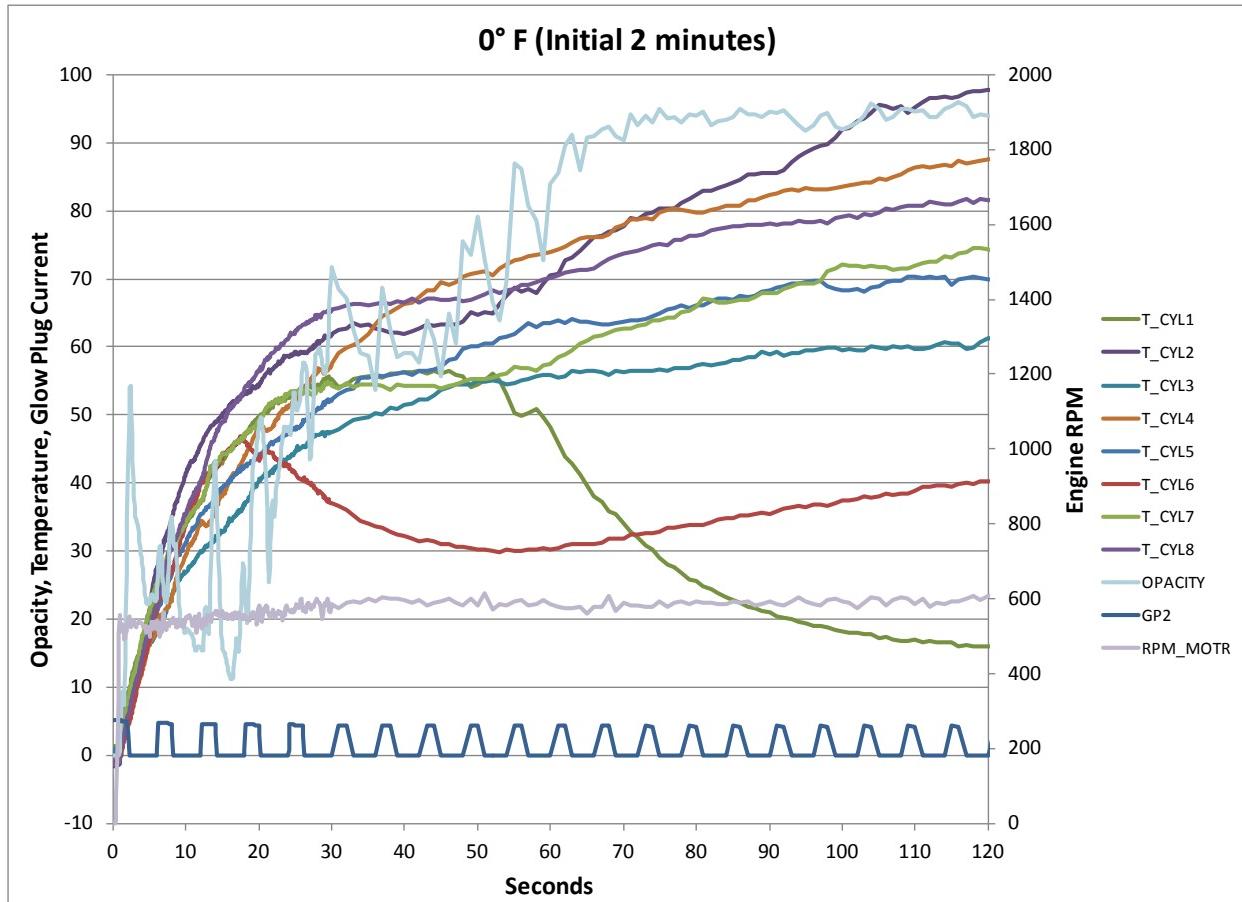
**Figure C-18. Low Cetane Cold Start at 0 °F (Initial 2 Minutes)**

At 0 degrees Fahrenheit, the engine was again unable to start without the use of glow plugs. As seen in Figure C-18, the engine started immediately with no hesitation, firing on all cylinders. After 20 seconds, cylinder 6 stopped firing followed by cylinder 1 at about 60 seconds. The data is continued in Figure C-19.

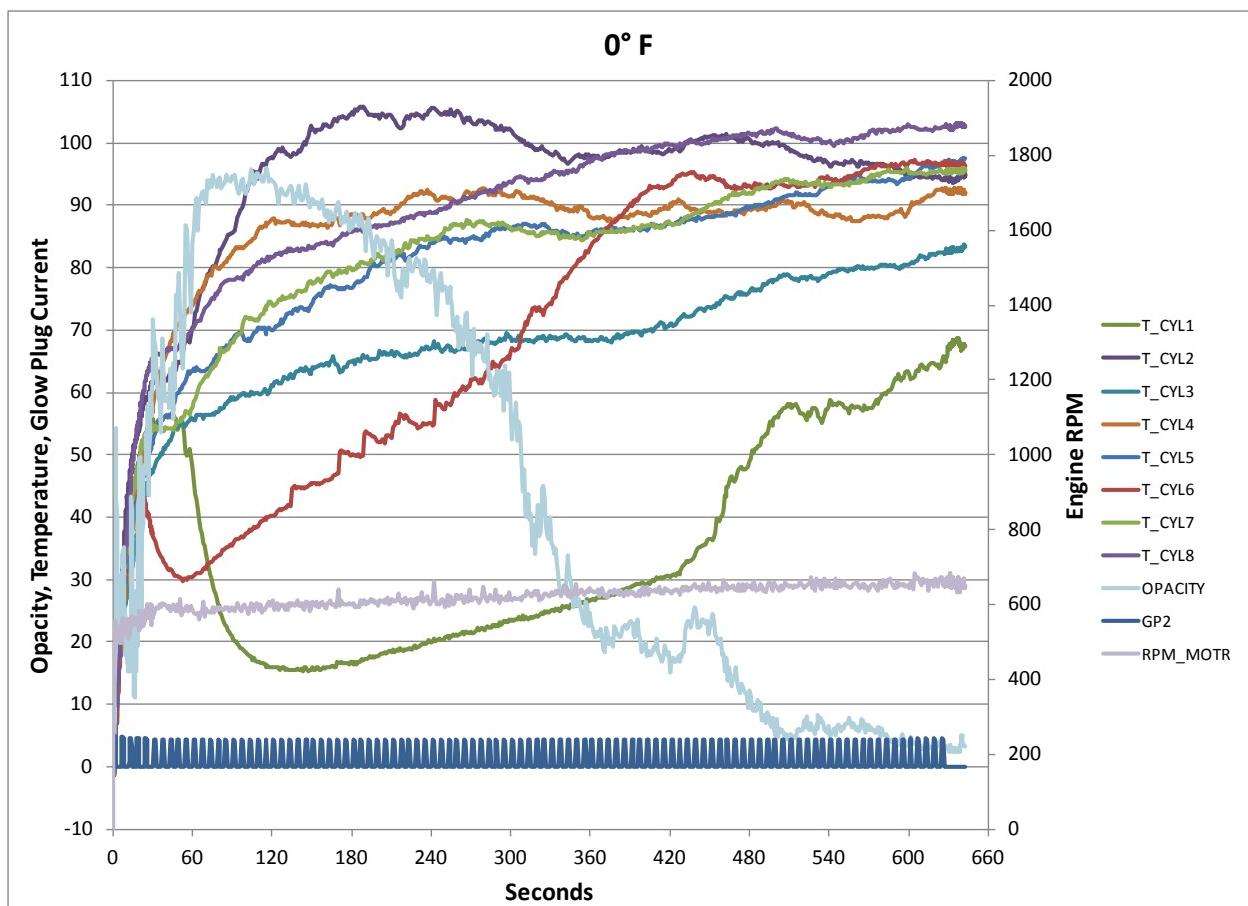
**Figure C-19. Low Cetane Cold Start at 0 °F**

Cylinder 6 continued to gain heat from the surrounding cylinders and started firing intermittently at about 120 seconds. Around 300 seconds consistent combustion was achieved on cylinder 6. Cylinder 1 did not fully relight until 480 seconds after ignition began.

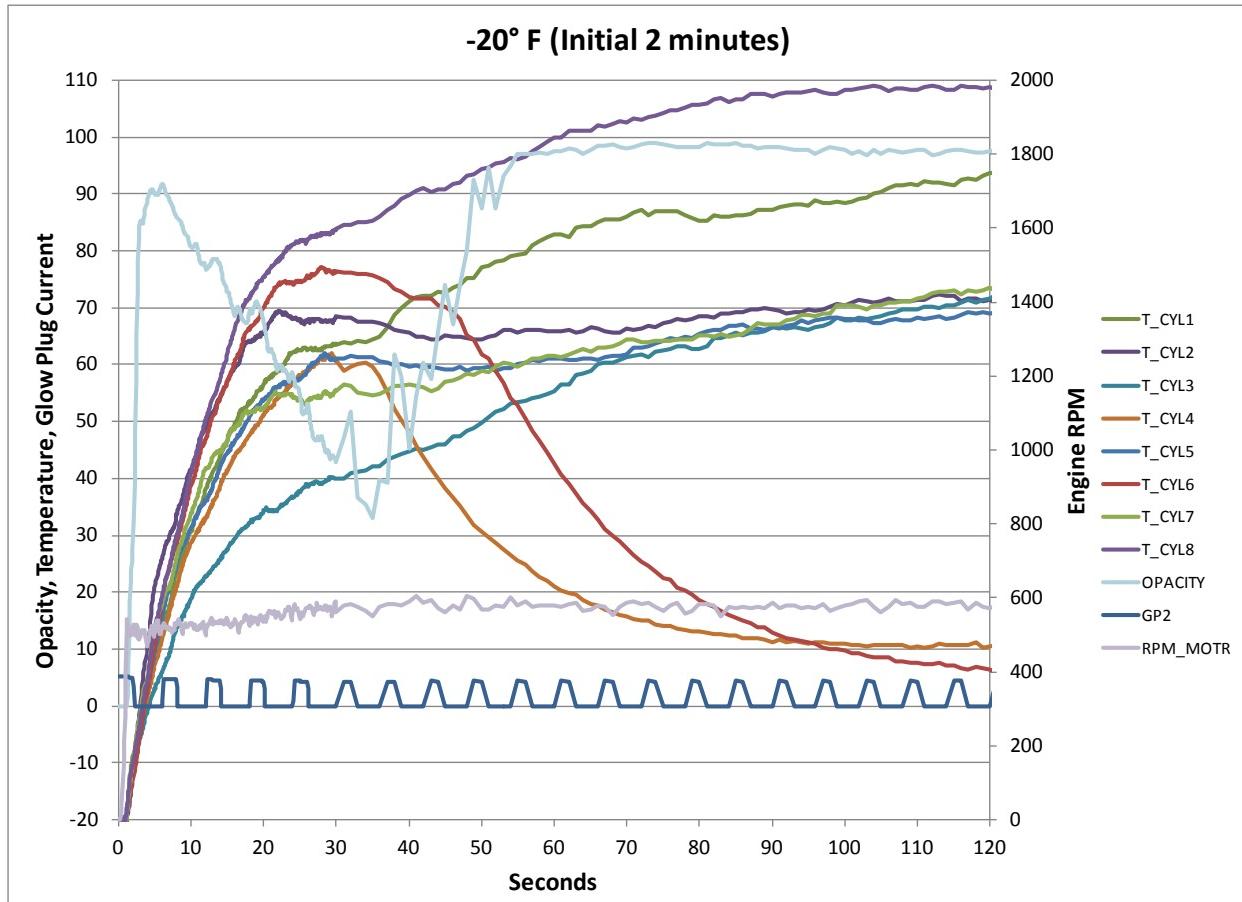
**Figure C-20. Low Cetane Cold Start at -20 °F (Initial 2 Minutes)**

At -20 degrees Fahrenheit, the engine was again unable to start without the use of glow plugs. As seen in Figure C-20, the engine started immediately with no hesitation, firing on all cylinders. The opacity decreased for the first 30 seconds until cylinders 4 and 6 stopped firing. The data is continued in Figure C-21.

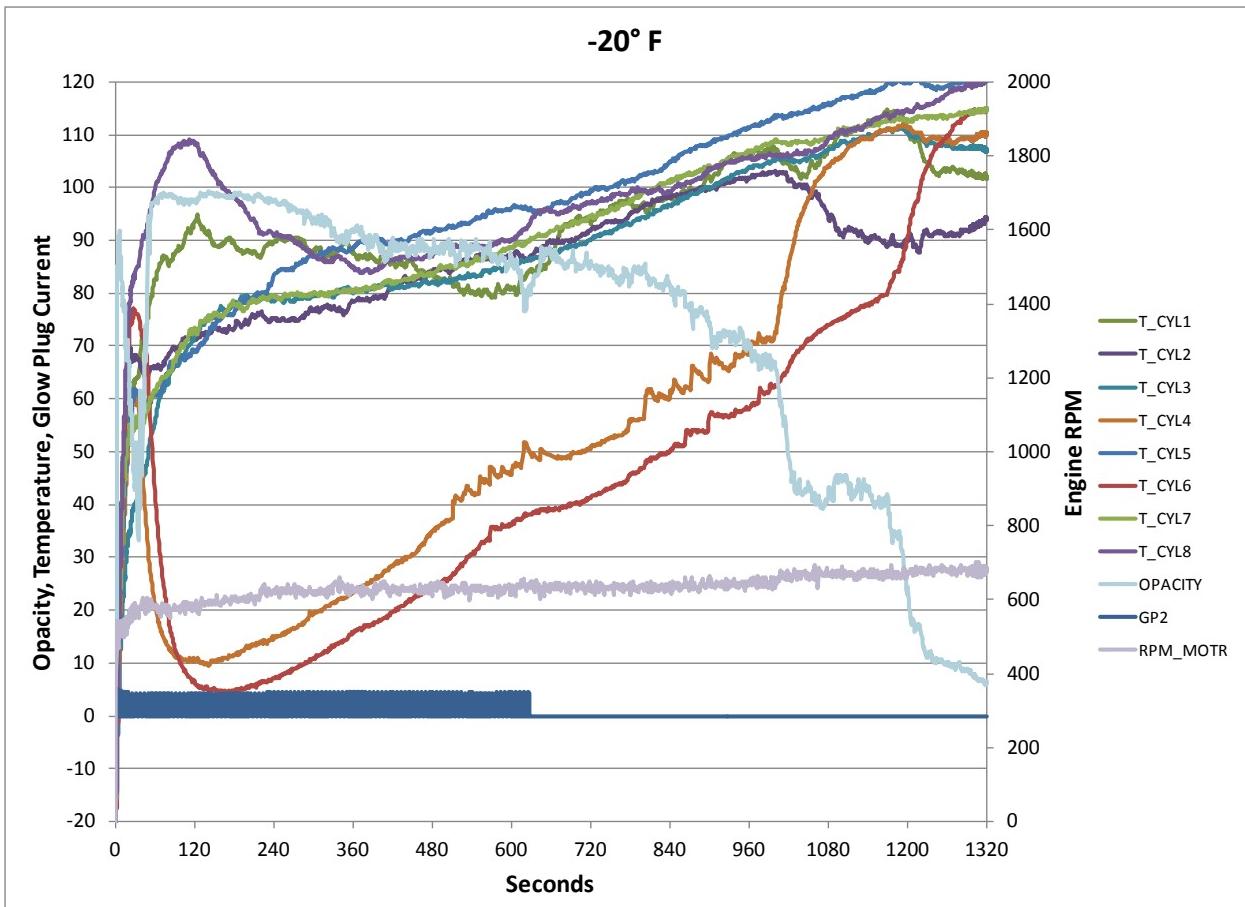
**Figure C-21. Low Cetane Cold Start at -20 °F**

For almost a full 9 minutes the engine slowly warmed up on 6 of the 8 cylinders. Between 500 and 600 seconds, cylinders 4 and 6 attempted to relight, and fired occasionally for another 500 seconds. After 630 seconds of operation, the glow plugs are automatically disabled to prolong their life. Cylinder 4 fully relit after almost 17 minutes, and cylinder 6 relit successfully a full 20 minutes after ignition.
